STOUT CREEK ASSESSMENT AND RESTORATION PLAN

River Design Group, Inc.
311 SW Jefferson Avenue
Corvallis, Oregon 97333

June 1, 2009

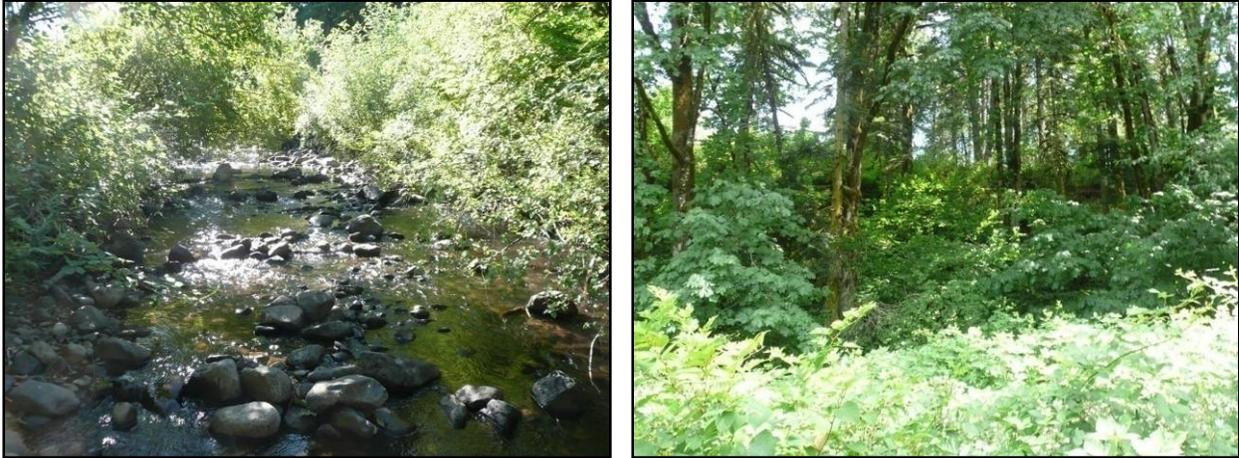
Figure 3-1. Examples of riparian conditions in Stout Creek. Willows and other shrubs are common riparian understory species (left). A view of the riparian forest shows blackberry in the foreground, with bigleaf maple, vine maple, and some alders and Douglas fir common in the overstory (right).

Historical aerial photographs indicate that much of the riparian vegetation along the Stout Creek assessment reach had already been removed by 1953. Much of the land that once supported upland vegetation was converted to for agricultural development. Remaining patches of older trees are mostly on hillslopes that are too steep for farming, and they are most extensive on the inside bend of stream channel meanders.

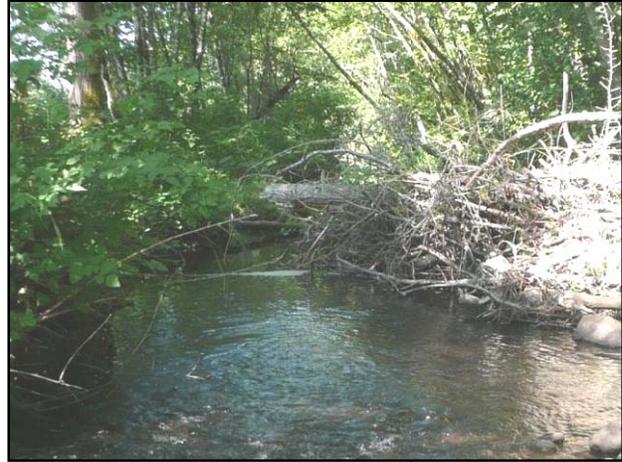
Figure 3-2. An example of potential juvenile steelhead and salmon rearing habitat in Stout Creek

Rearing: Juveniles may rear in Stout Creek for as long as 4 years. Juvenile steelhead prefer pools with cover, large wood (Figure 3-2), cool water temperatures (less than 64°F), and high dissolved oxygen levels.

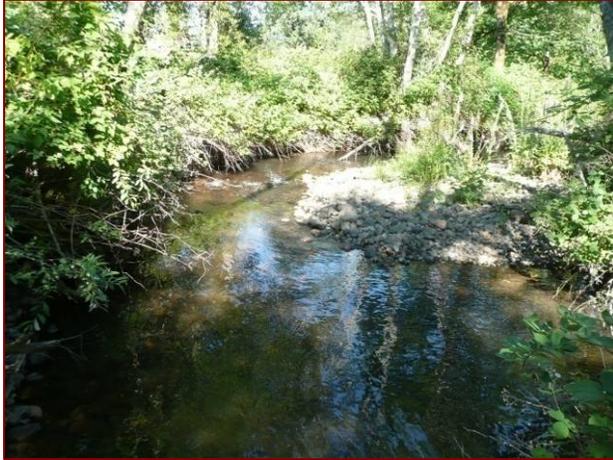
Figure 3-3. An example of a gravel bar at STA 42+00 in Reach 1. Gravel bars are important for aquatic invertebrate production and spawning habitat for salmon and steelhead.

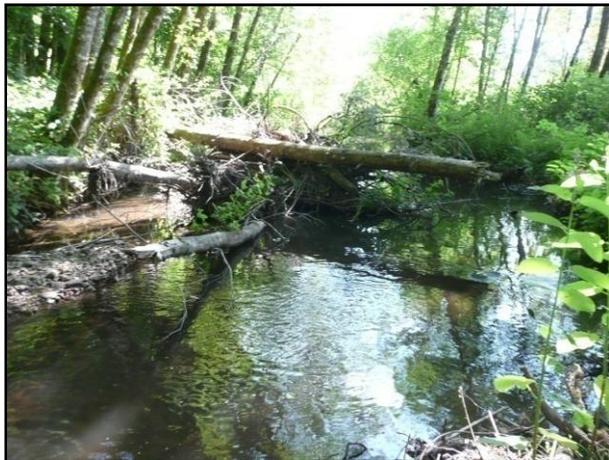
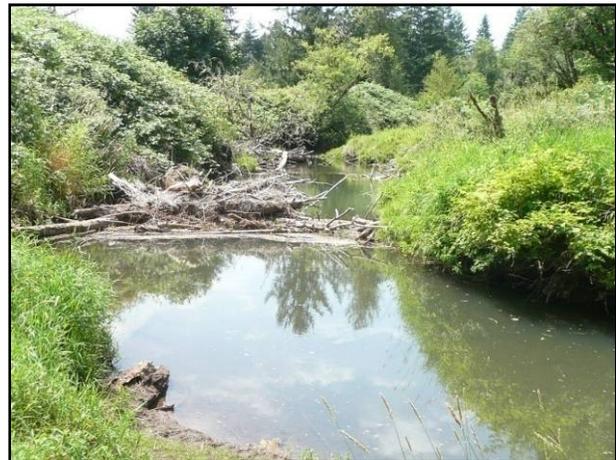
Figure 3-4. Large wood provides overhead cover for fish habitat and also influences channel morphology. Large wood is a vital component for maintaining fish habitat in Stout Creek. Photographs are from STA 4+50 in Reach 1 (left) and STA 66+00 in Reach 2 (right).

Large wood historically played an important role in creating habitat diversity in Stout Creek (Figure 3-4). However, removal of riparian vegetation and large wood from the creek has reduced the prevalence of habitat-forming trees in Lower Stout Creek. As in other areas in the Willamette Valley, logs on the floodplain are often cut, either for firewood or to reduce the chance of logs damaging property or infrastructure during floods. Large wood is important for fish in streams and rivers because it creates pools, hiding areas, and gravel bars, provides a substrate for aquatic insects, and contributes to channel habitat complexity.

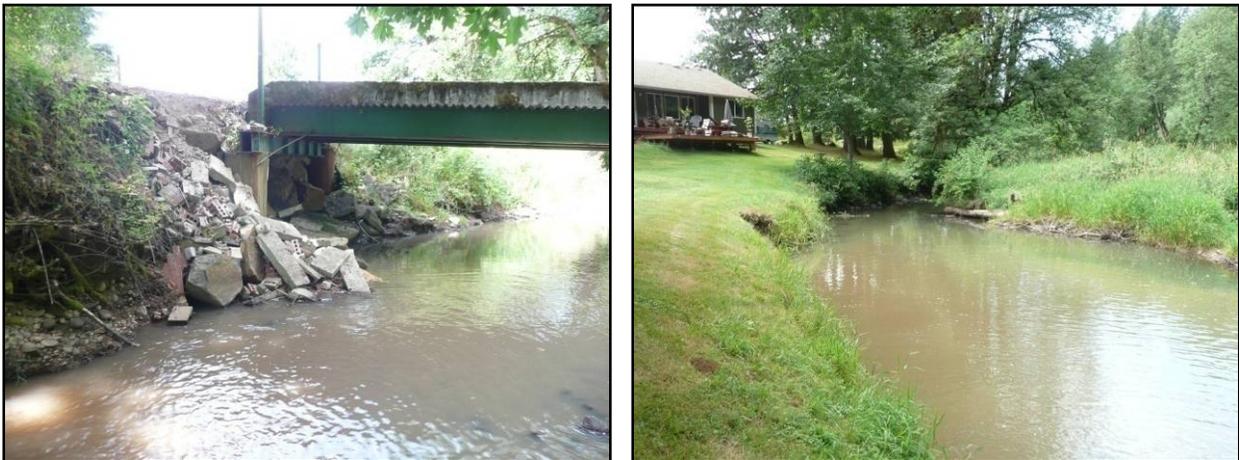
Figure 3-5. Examples of bank erosion in the lower Stout Creek assessment reach. Erosion tends to occur at a faster rate in zones with no riparian vegetation than in areas with in-tact riparian vegetation and large trees that divert flows away from the bank.

There is evidence of bank slumping and erosion in the Stout Creek assessment reach, especially on the outside curve of stream meanders (Figure 3-5). In addition to being a concern for landowners, streambank failures release large inputs of fine sediments into the creek, which may be detrimental to fish species. However, controlling natural meanders on one segment of stream can cause downstream erosion, often creating problems for neighboring landowners, if localized energy dissipation is not combined with the bank stabilization. By decreasing the meandering of a river, water velocity increases, downcutting of the river bottom may occur, gravel bars become coarser, and pool habitats decrease, all of which are detrimental to fish.

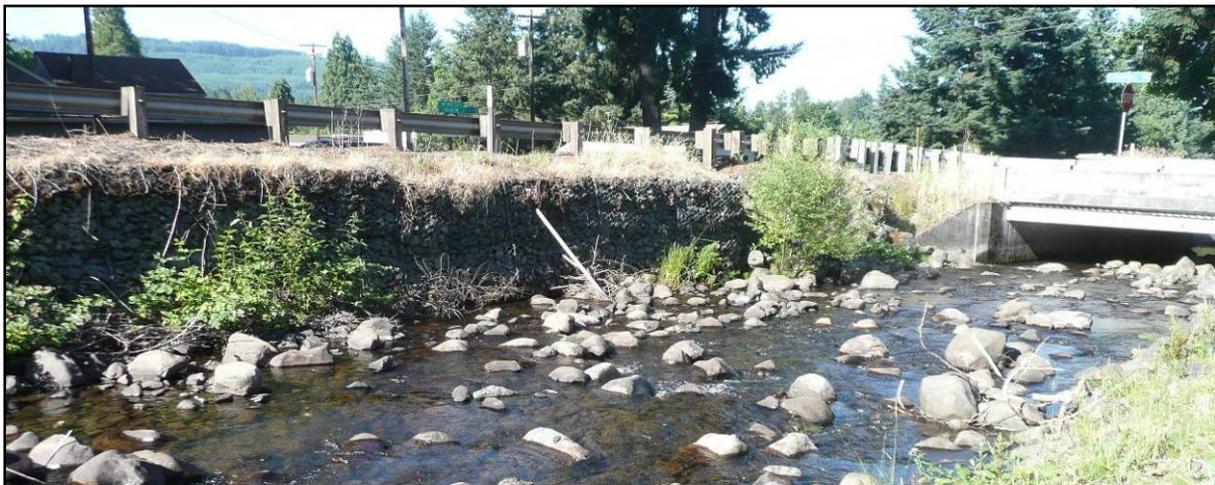
Figure 4-1. The gabion wall upstream of the Fernridge Road Bridge limits lateral channel migration and protects the road. Photograph is taken from the right bank just upstream of the bridge.

Bank stabilization and erosion sites were noted during the field reconnaissance. Bank stabilization in Reach 1 was limited to an approximately 100-ft gabion wall along the south stream bank upstream from the Fernridge Road Bridge (Figure 4-1). A floodplain levee paralleling the southern streambank was placed to limit flooding of nearby buildings.

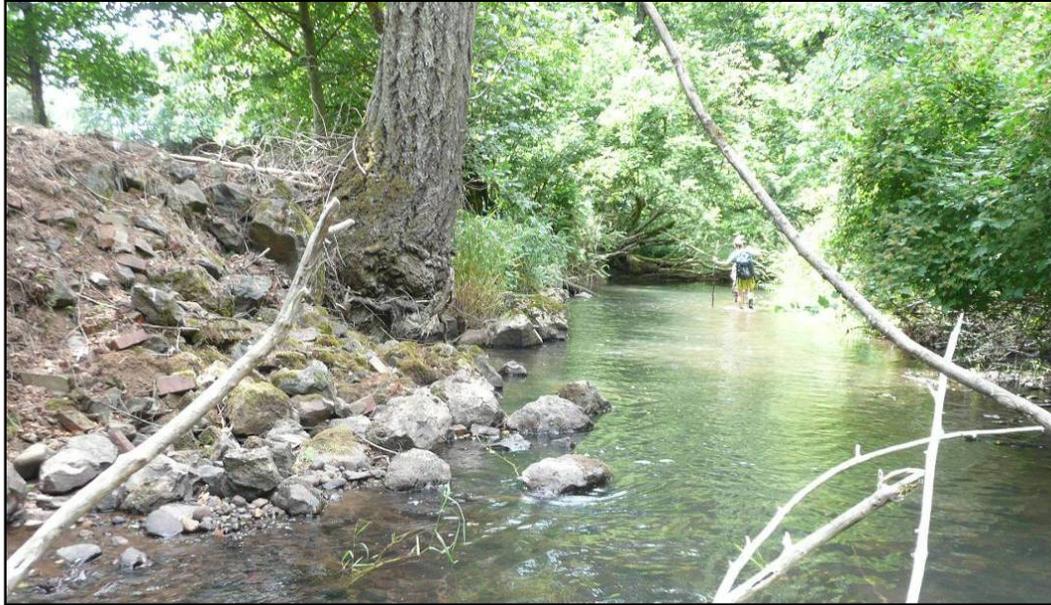
Figure 4-3. Bank stabilization site in Reach 2. Rock fill was added to the left bank to slow erosion.

Bank stabilization and erosion sites were limited in Reach 2. There is one area of rock fill used for bank stabilization in Reach 2 upstream of the Highway 22 Bridge. Figure 4-3 illustrates bank stabilization treatments in Reach 2.

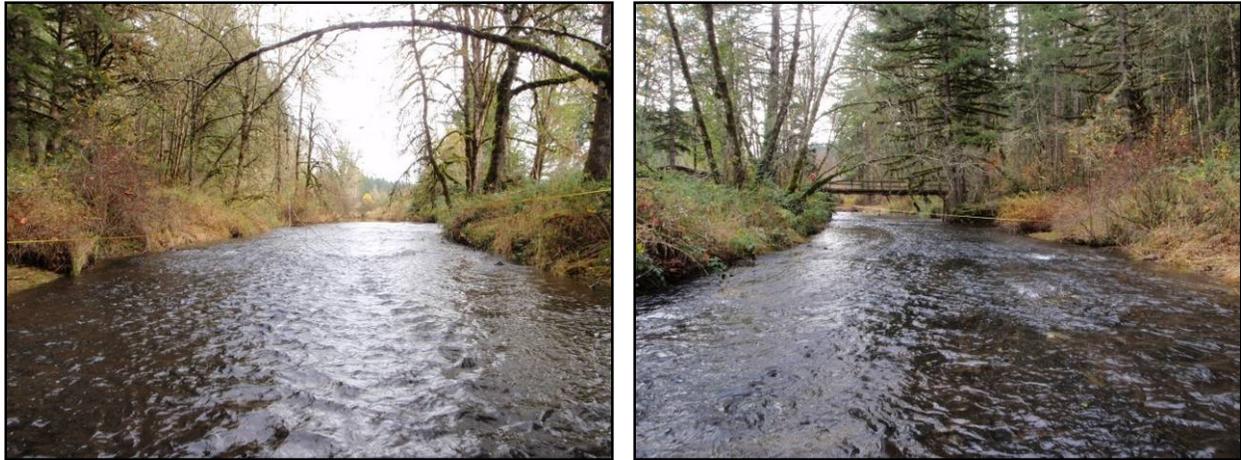
Figure 4-4. The cross-section at STA 71+00. The photographs show the view looking upstream (left) and downstream (right) from the site of the cross-section.

The survey included a cross-section and channel profile. Summary information from the survey is included in Figure 4-4. The photos capture typical river corridor conditions in the vicinity of the Phantom Lane Bridge. Himalayan blackberry is growing on the left bank. The right bank is the side of the hillslope, but medium density riparian vegetation provides some measure of stability to the bank. Beyond the riparian corridor, the left floodplain is used for rural residence. The cross-section also exhibits the relatively flat channel bottom that predominates through this bedrock section of Stout Creek.

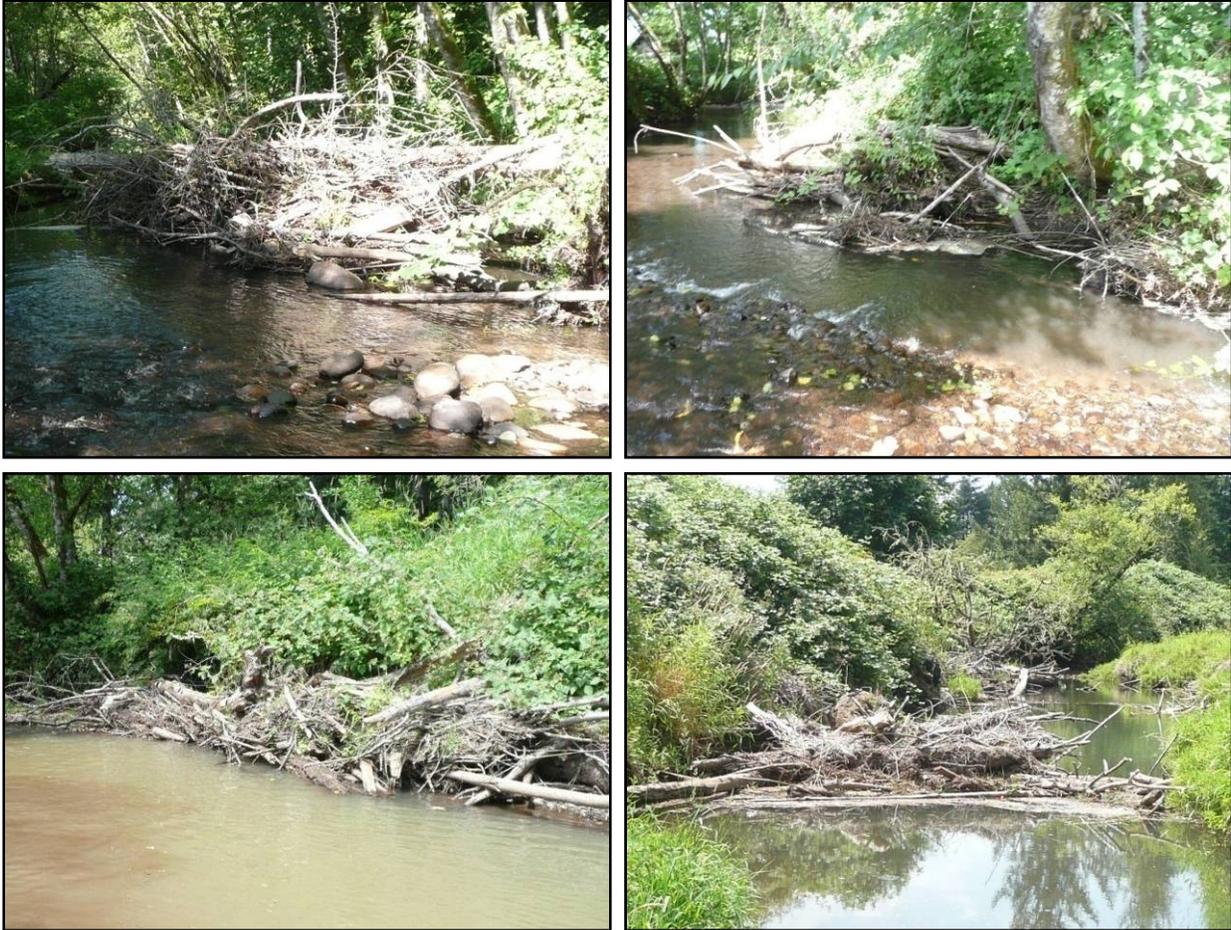
Figure 5-1. Examples of large wood in Stout Creek. Large wood influences sediment deposition patterns, focuses stream flow to create scour pools or deflect flow away from streambanks, provides cover for fish and wildlife, and captures additional debris.

How wood functions also depends on its location within the river corridor. Wood in the mainstem river is typically more mobile than floodplain wood, since mainstem woody debris experiences higher velocities and shear stress. Vegetation can trap large wood and create rafts of debris. Vegetation may also colonize the fine sediments that typically deposit in the leeward direction of wood, and over time, vegetation anchors the wood. Figure 5-1 includes several examples of large wood in Stout Creek. Photos illustrate the role of wood in forming channel morphology, providing fish habitat, and influencing channel hydraulics.

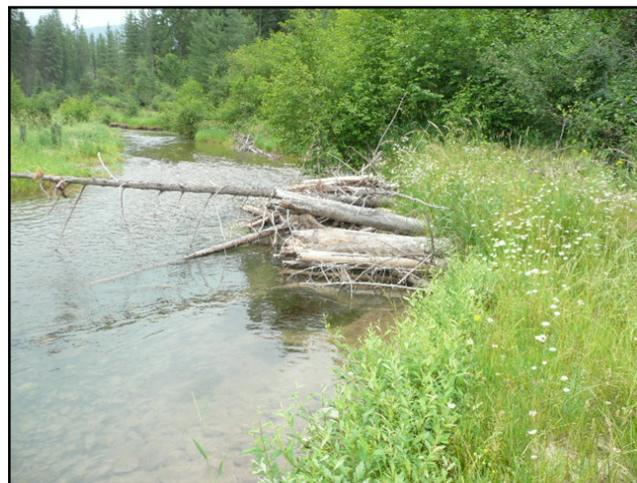
Figure 5-2. A large wood habitat composite and vegetated soil lift on Elk Creek in western Montana.

Large wood will be installed both singularly and in aggregate to ensure channel stability, provide habitat, and to trap sediment. These structures will be smaller than ELJs and require less material (Figure 5-2). In general, each structure will include at two rootwads and several logs for ballast. Orienting wood along the channel margin will deflect flows and provide bank stability. Placing trees in the channel alignment can promote several types of habitat. For example, large wood in a pool provides overhead cover and interstitial space. Wood in a run will promote vertical scour at the head of a pool.

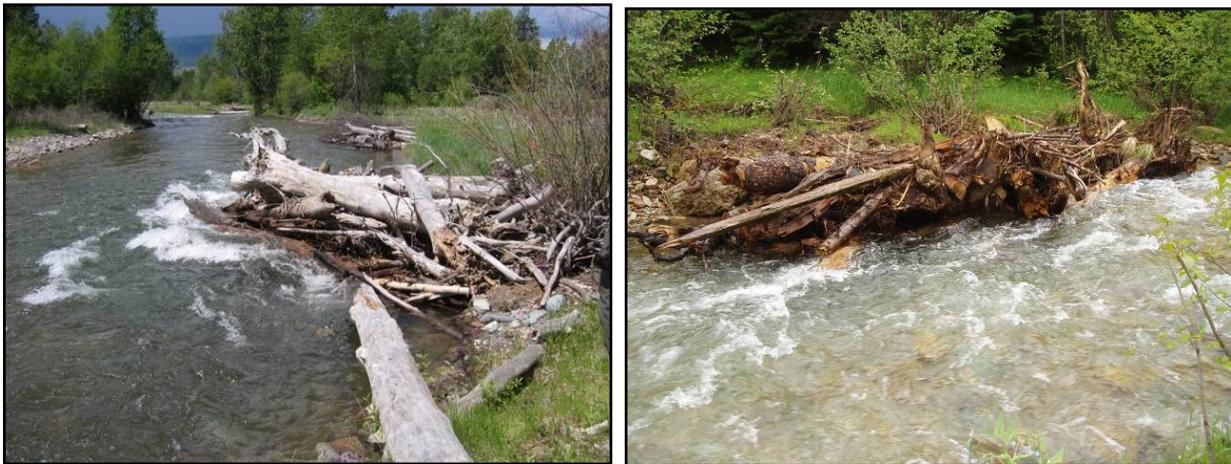
Figure 5-3. Example engineered log jams on streams in western Montana.

Engineered log jams (ELJs) are installed for bank stabilization, flow deflection, and mainstem river habitat. ELJs will be completed on the mainstem river and will provide complex cover for juvenile and adult fish. ELJs will be constructed with approximately 10 to 15 trees including rootwads, whole trees, and tree tops (Figure 5-3). To provide structure ballast, approximately 10 yd³ of large rock will be placed within each structure. The ELJs are also backfilled with native alluvium to reduce the potential for intra-structure piping. Rootwad sizes will average 3 ft to 4 ft in fan diameters and have minimum stem lengths of 30 ft. ELJs span from the predicted scour depth to above the bankfull channel elevation to provide a range of fish habitat and structure stability.

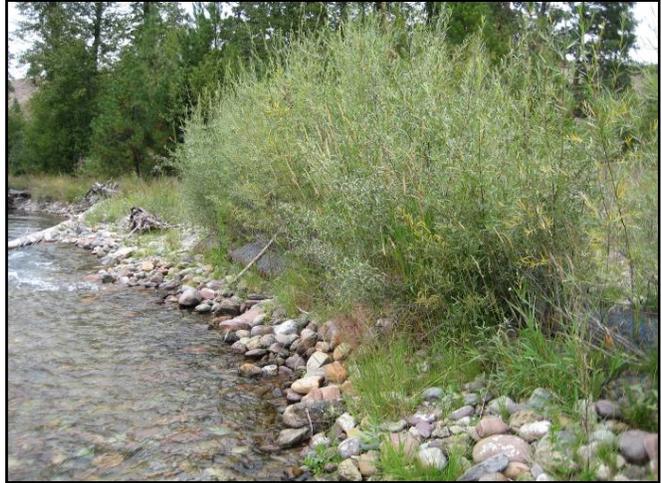
Figure 5-4. Willows growing from a vegetated soil lift on the Jocko River during the fourth growing season.

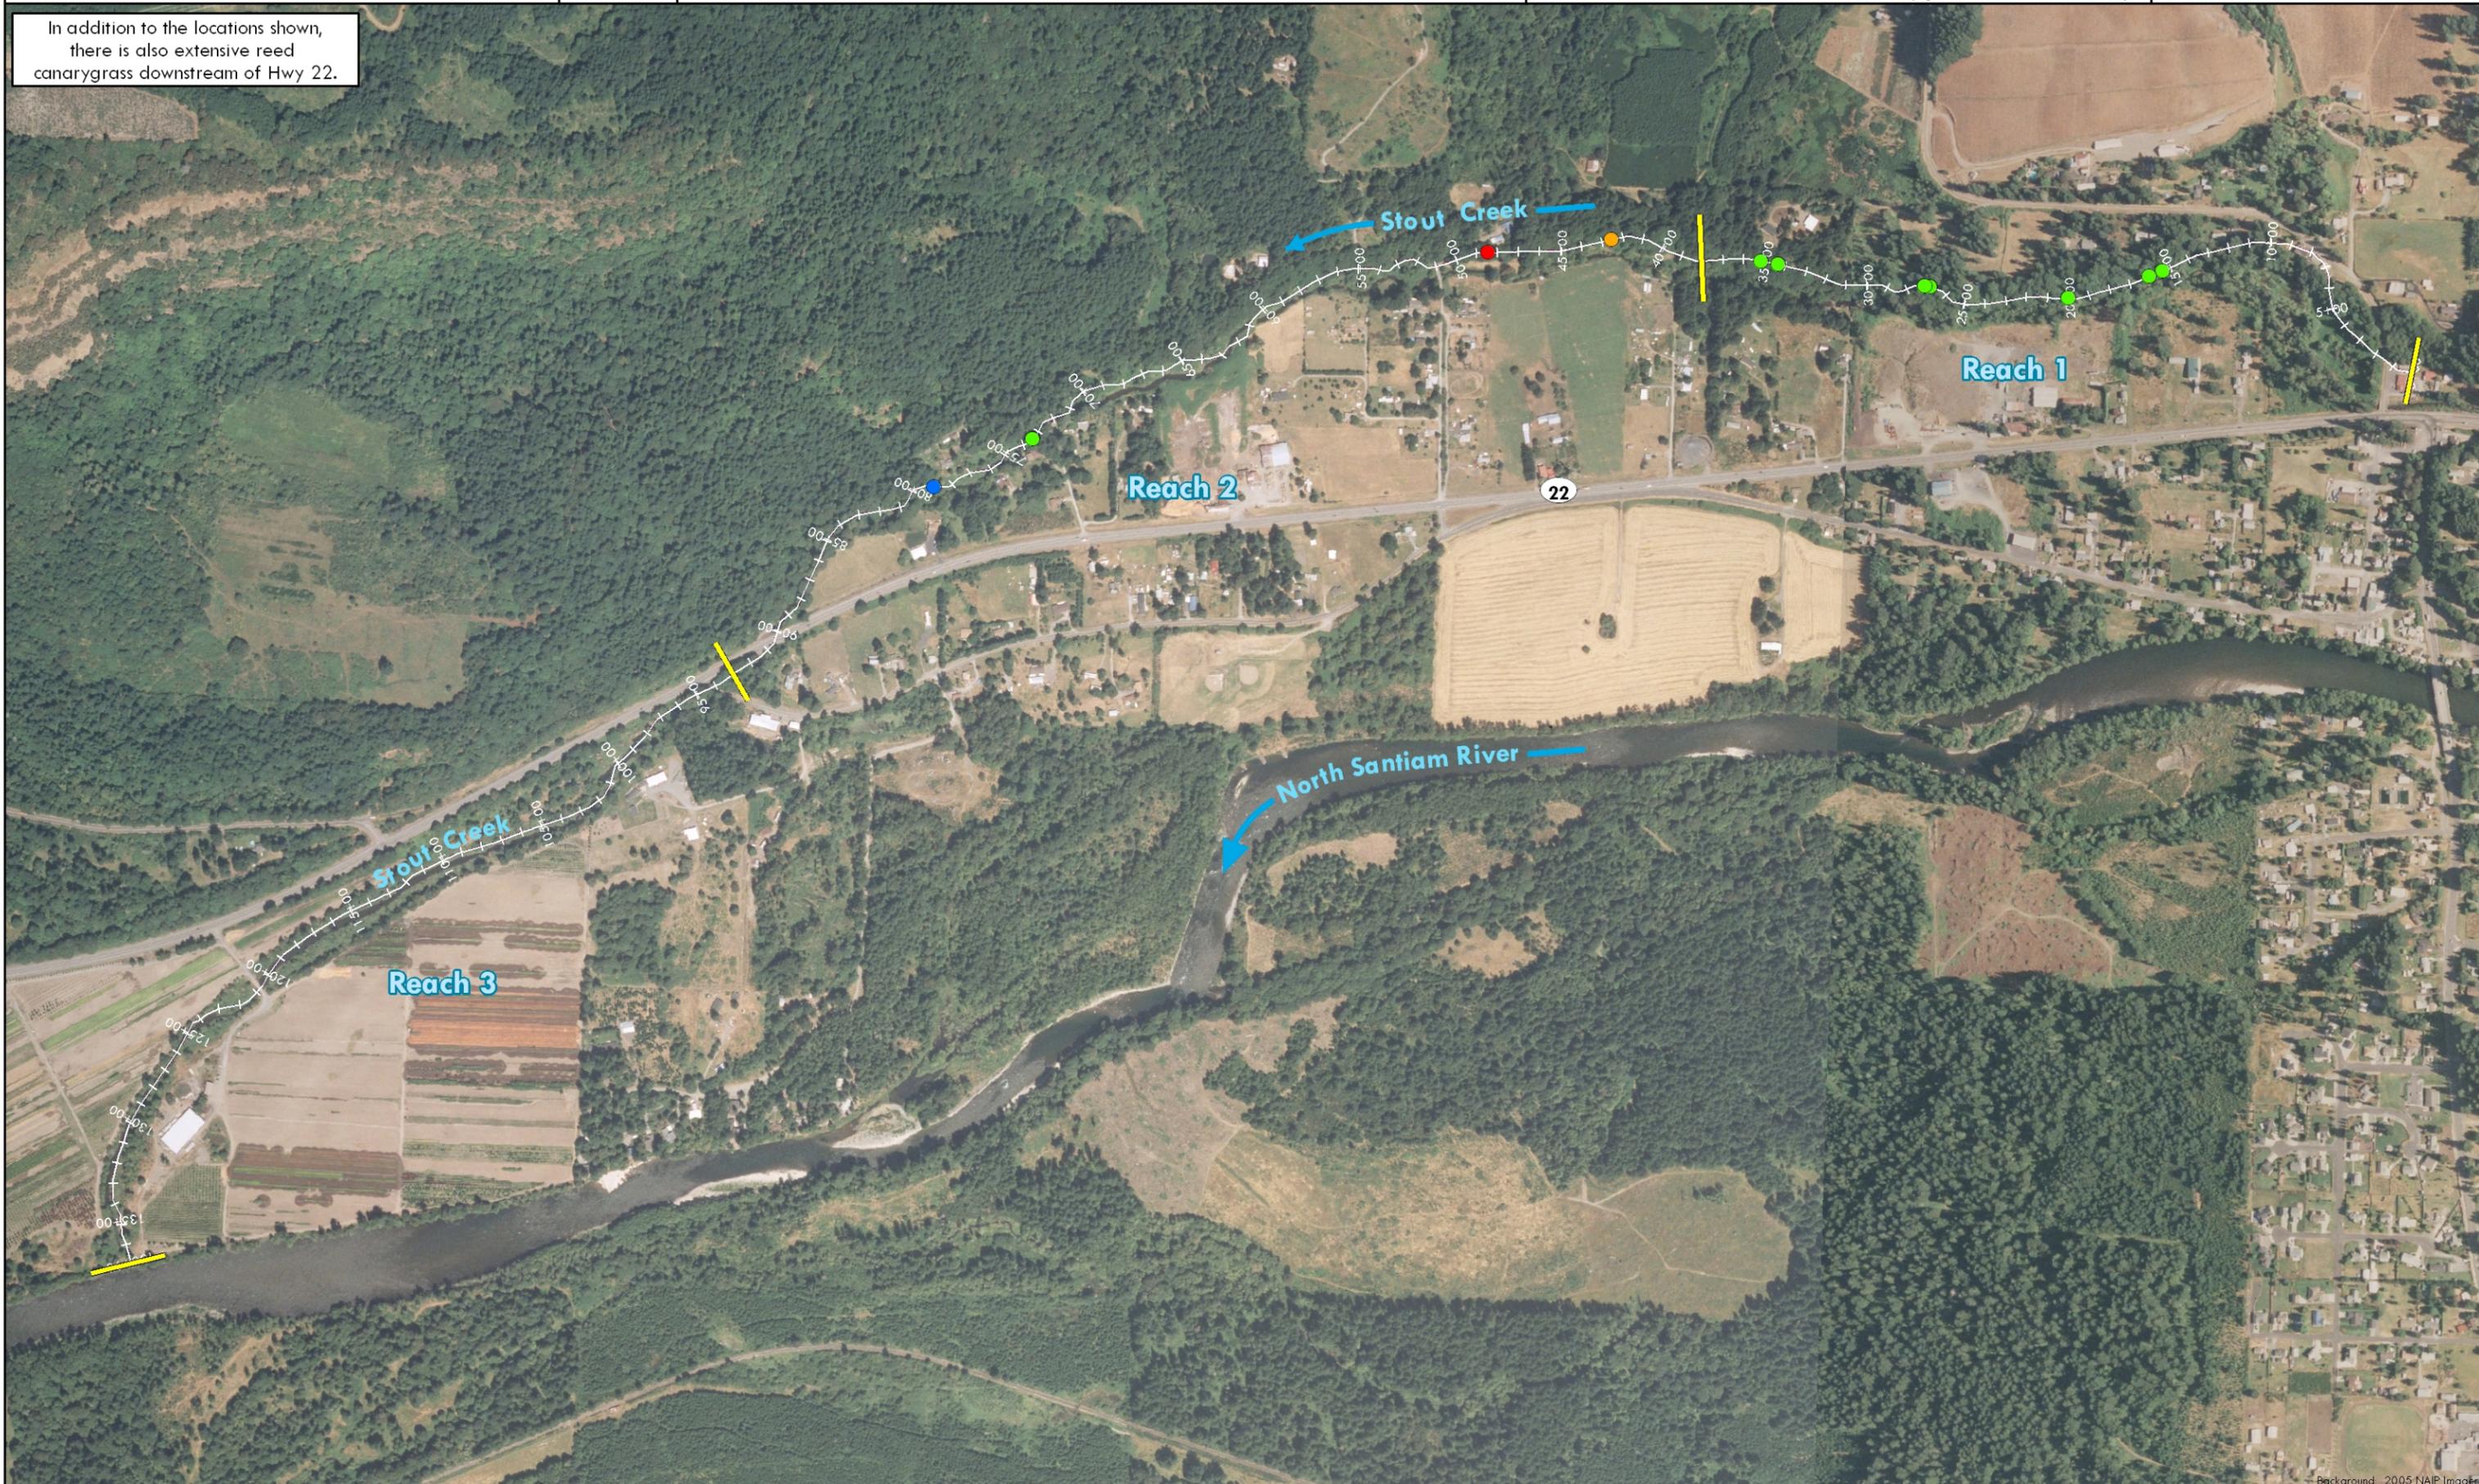
APPENDIX D
STOUT CREEK INVASIVE WEED LOCATIONS

In addition to the locations shown, there is also extensive reed canarygrass downstream of Hwy 22.

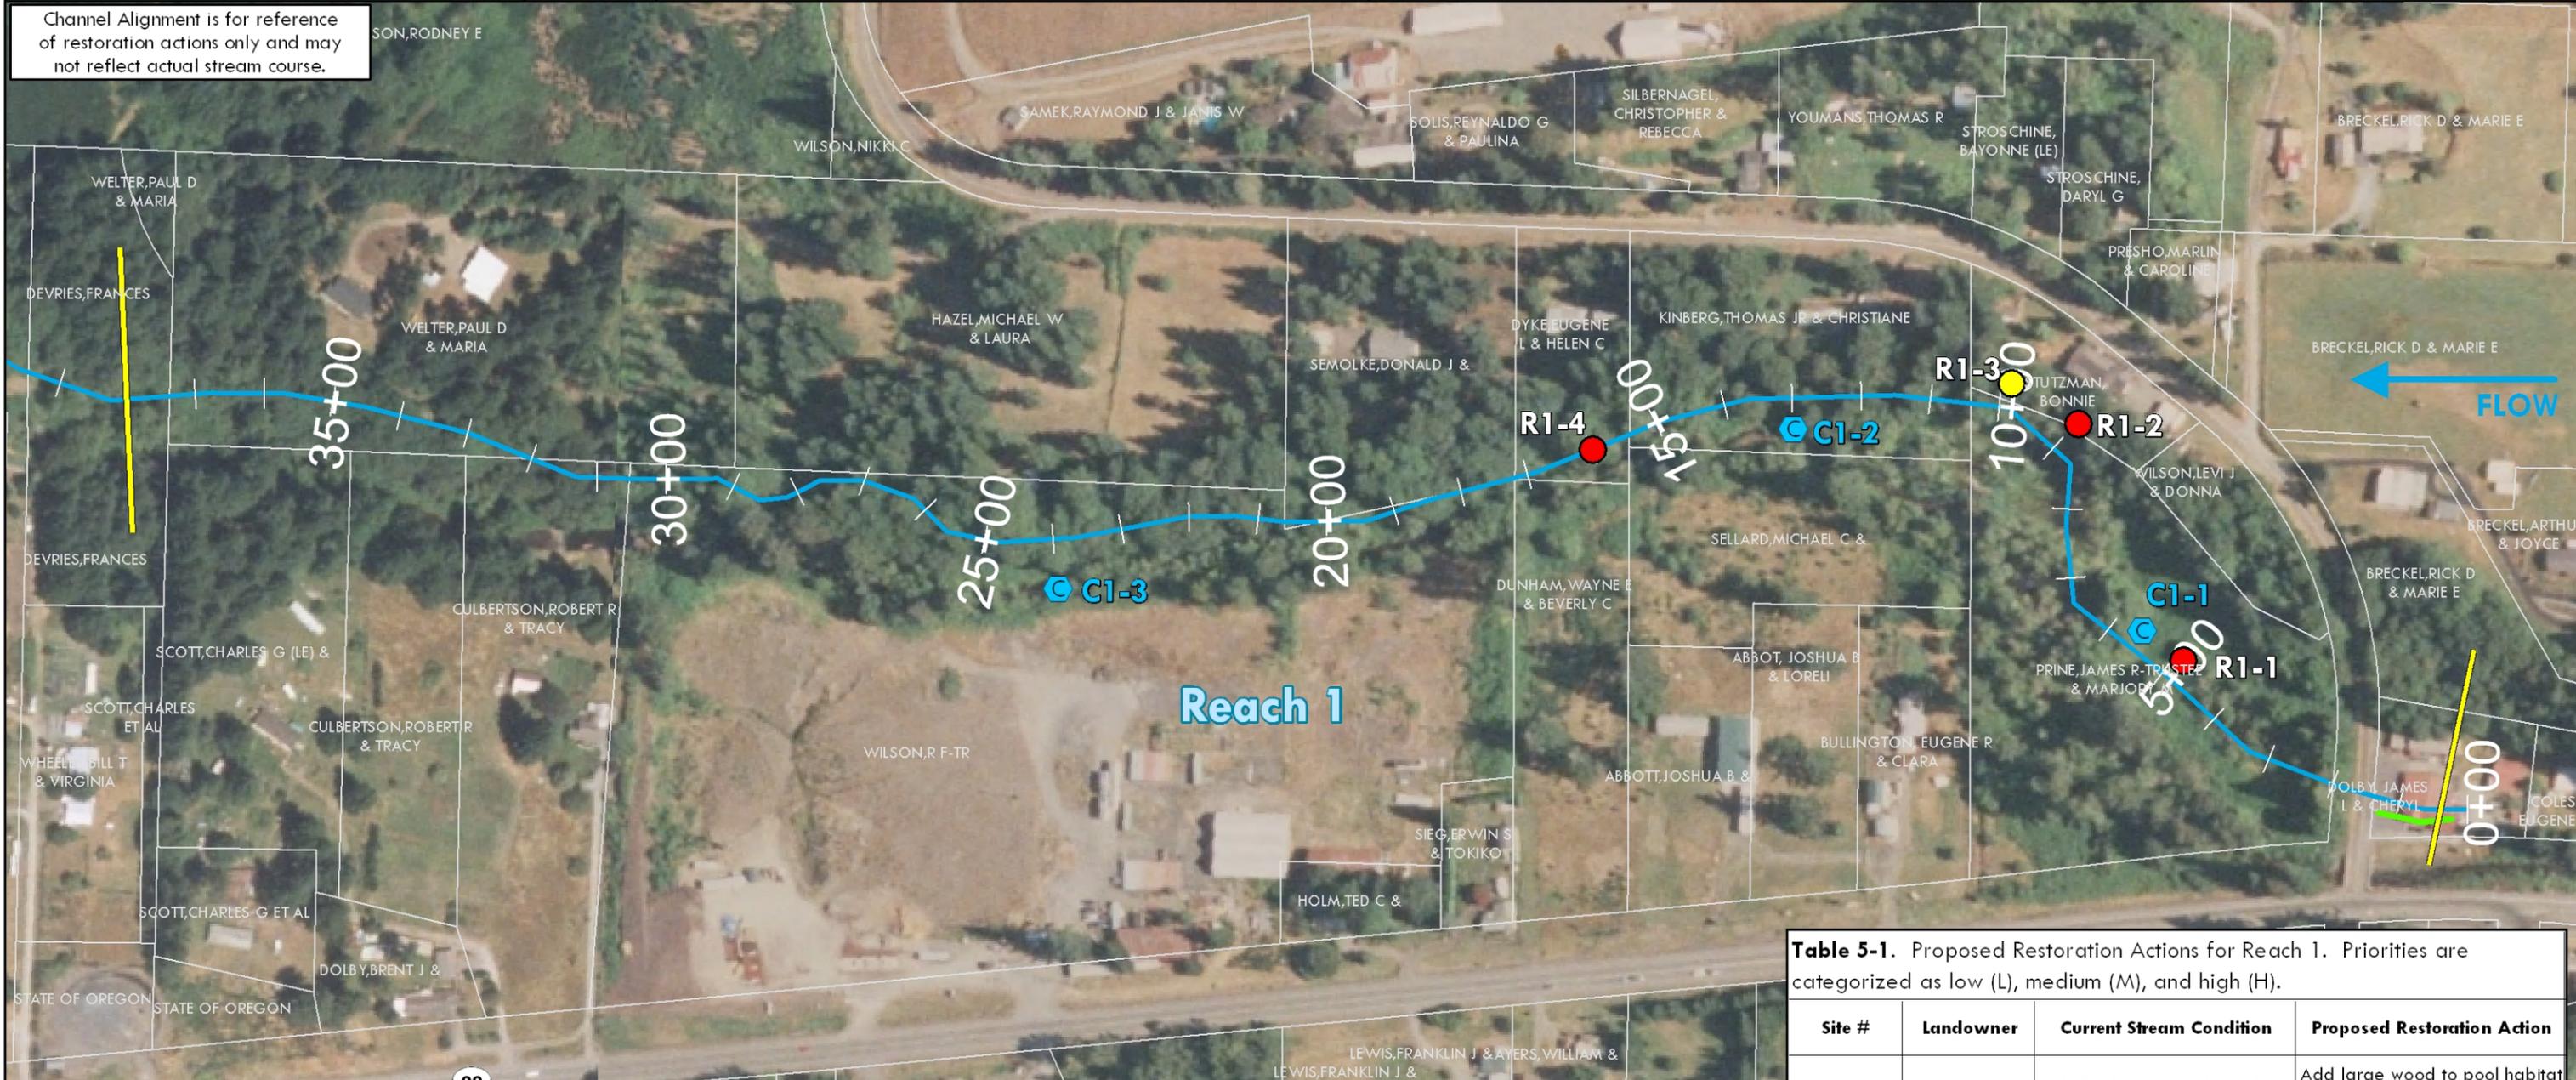
APPENDIX E
RESTORATION AND CONSERVATION SITES MAPS

Channel Alignment is for reference of restoration actions only and may not reflect actual stream course.

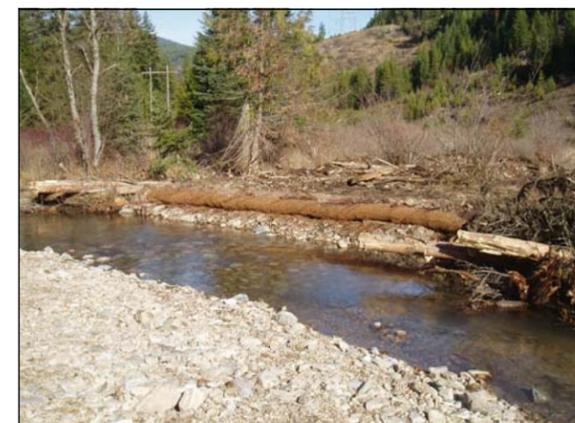
EXAMPLE OF VEGETATED SOIL LIFTS FOLLOWING CONSTRUCTION

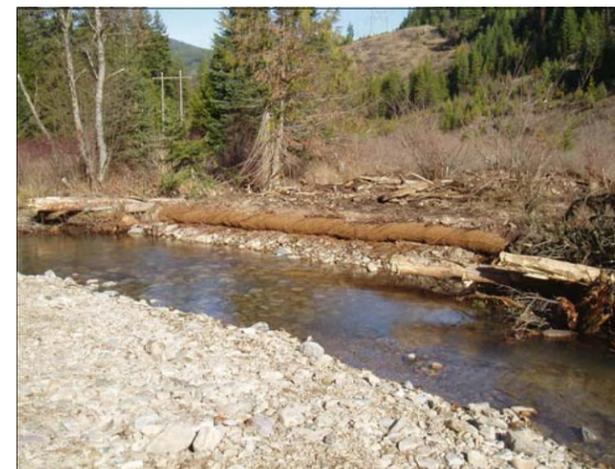
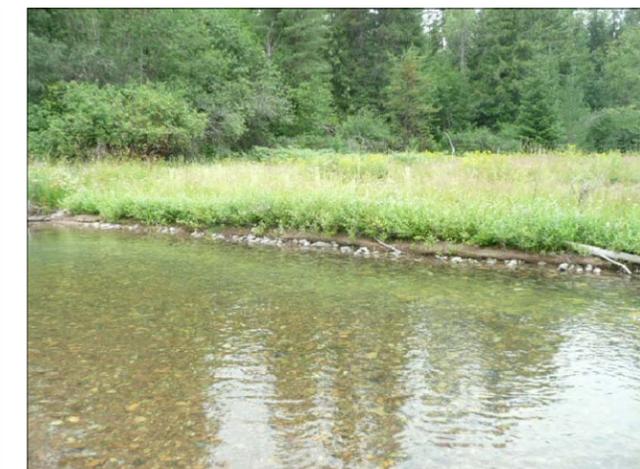
EXAMPLE OF VEGETATED SOIL LIFTS FOLLOWING CONSTRUCTION (LEFT) AND DURING THE SECOND GROWING SEASON (RIGHT)

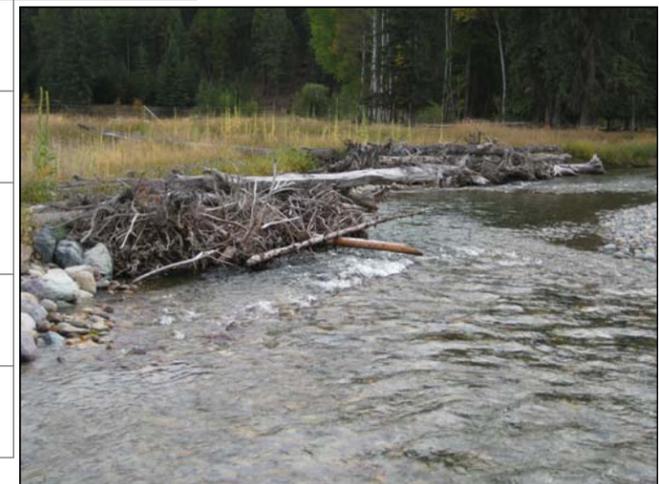
CONSTRUCTED LARGE WOOD HABITAT STRUCTURE WITH ADDITIONAL WOOD ADDED FOR HABITAT ENHANCEMENT
